**Hydrogeological Investigation of springs around Gangajamuna
Rural Municipality Wards 1 and 2, Dhading, Nepal**

Rotary Club of Dhading

Integrate Earth System (IES) Consult

2025

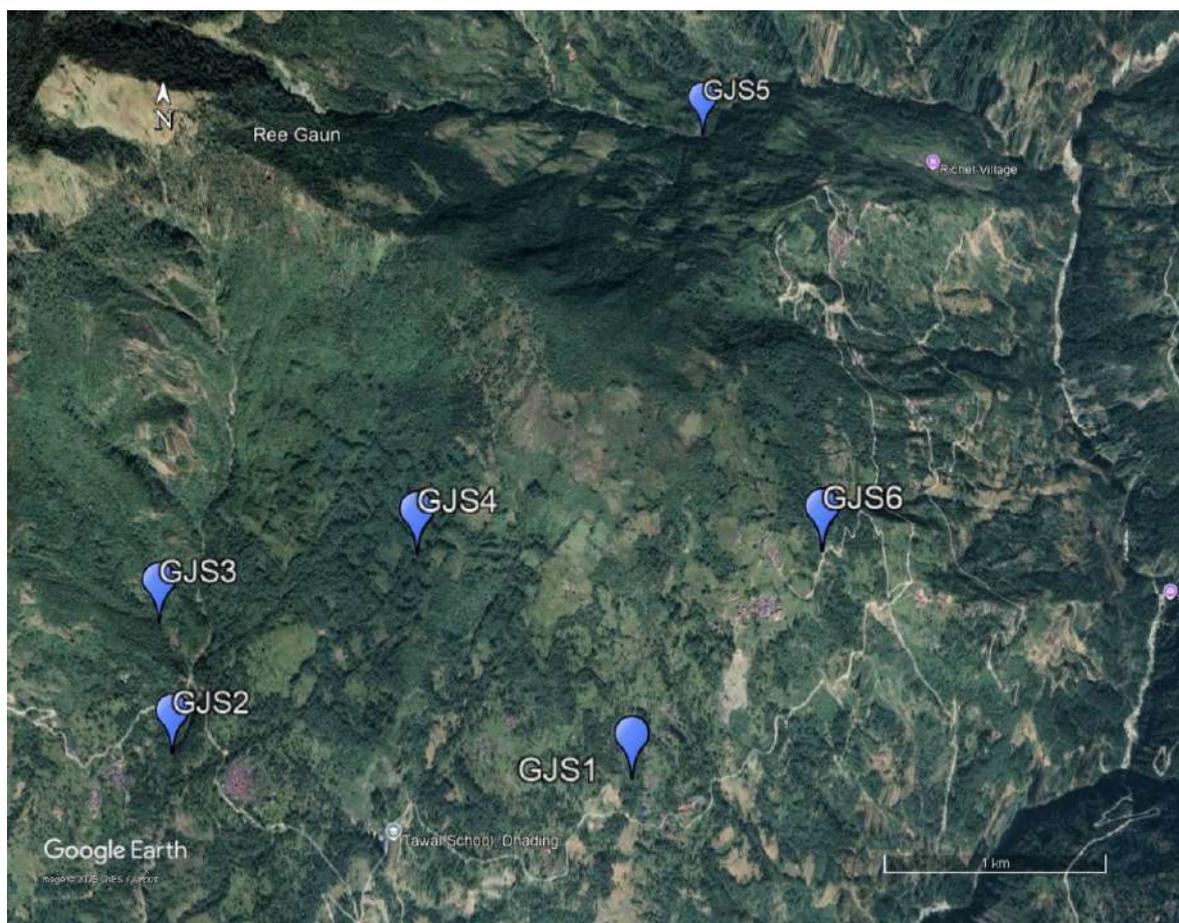
Figure 2. Distribution of springs on Google Earth imagery in the study area.

The hydrogeology of six spring sites of Ward 1 and Ward 2 of Gangajamuna Rural Municipality, Dhading were observed (Figure 2). Among six sites, four lie in Ward 2 and remaining two lies in Ward 1 of Gangajamuna Rural Municipality. The study area lies in the Midlands surrounded by Mahabharat Range to the south and the Himalaya Range to the north. The study area encompasses a prominent hill massif characterized by pronounced vertical relief and varied slope gradients.

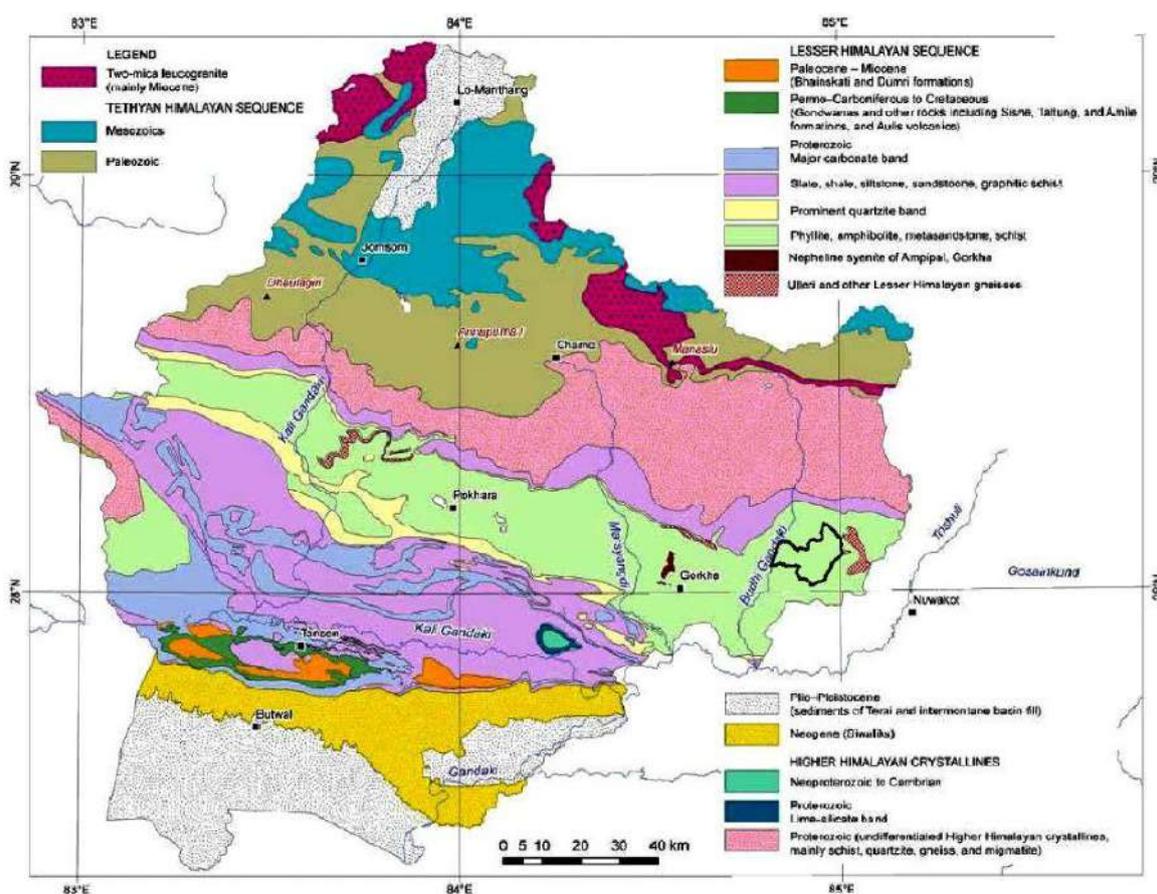
Figure 3. Gangajamuna Rural Municipality with a small dark black outline in simplified geological map of Gandaki Region (Dhital 2015).

Regionally, Gangajamuna Rural Municipality entirely lies within the Kuncha Formation of the Lower Nawakot Group of Nawakot Complex (Figure 3). This geological formation, the oldest unit of the Himalaya is characterized by a uniform lithological composition consisting greenish grey phyllite, quartzitic phyllite, phyllitic metasandstone, gritstone, micro-conglomerate, and black schist, which sometimes exhibits amphibolite bands.

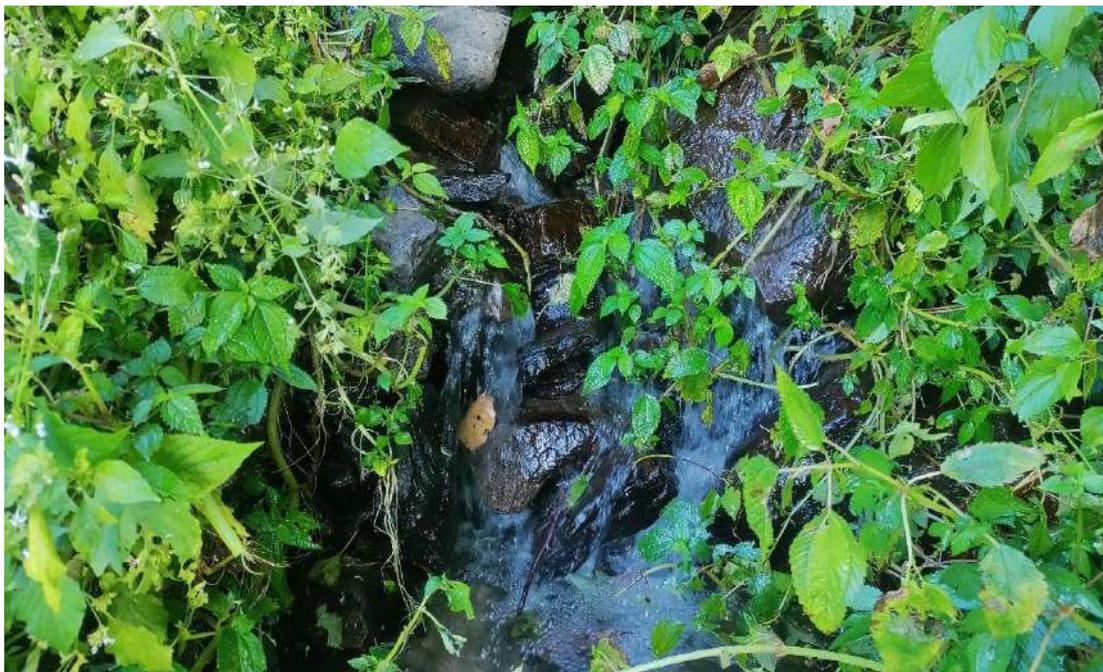
Photograph 1. Kelsyong Khola flowing over fractures rocks in Salleri.

The source is located near Salleri village (Photograph 1). It is a stream which originates at about 200 m uphill from the observation site (Figure 4). Colluvial deposits with the vegetation cover with mostly Utis trees at both banks of the stream were observed (Photograph 2). The estimated discharge of GJS1 was 5 lps.

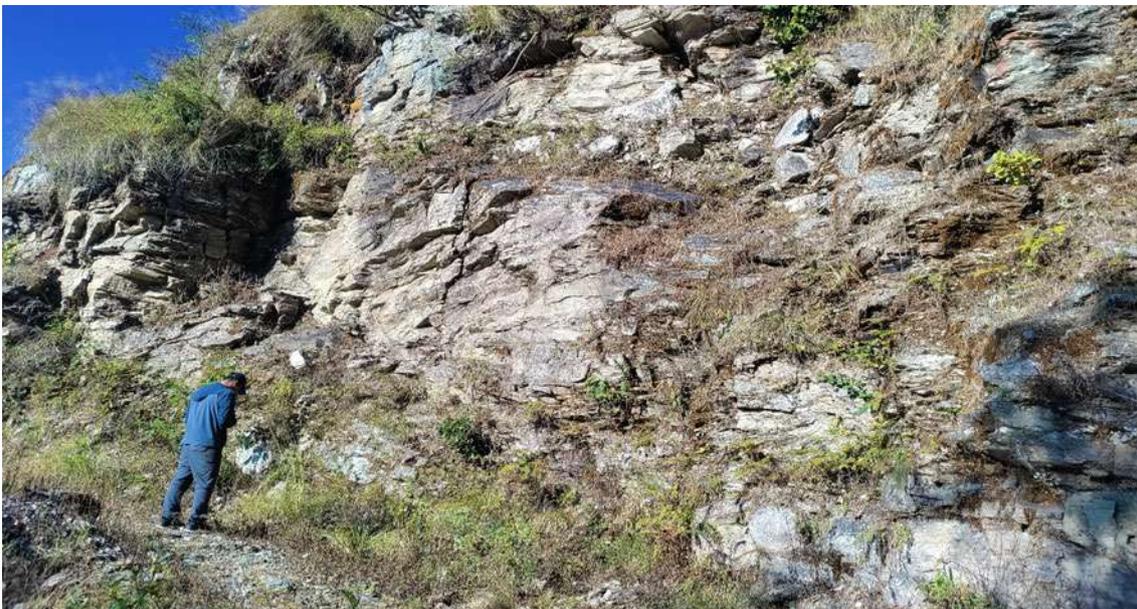
Photograph 2. Highly fractured phyllite, interbedded with metasandstone, is exposed near Salleri Khola.

At about 40 m away from the right bank of the stream, the rock exposure was observed (Photograph 3). Slightly to moderately weathered greenish grey phyllite interbedded with metasandstone was seen. The exposure was highly fractured. The orientation of the foliation and joint sets of the rock exposure were noted. The aperture of about 2 cm to 5 cm was seen at joint set 2.

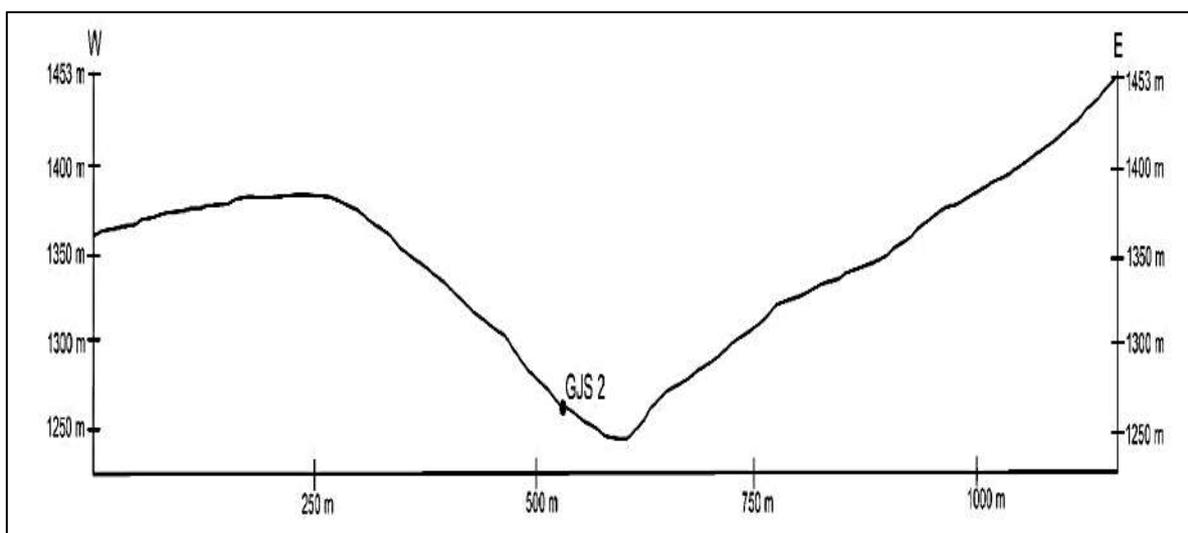
Figure 5. Elevation profile of Kalshyong Khola (Tawal besi).

It is located near Tawal Besi Village. It is a stream, flowing with high gradients (Photograph 4). In the observation site, it was seen that two streams are converging to form a bigger stream. This stream originates at about 400 m uphill from the observation site (Figure 5). The estimated discharge of GJS2 was 32.5 lps. Cliff is observed at both banks of the stream at downstream whereas at upstream, vegetation cover with trees were seen.

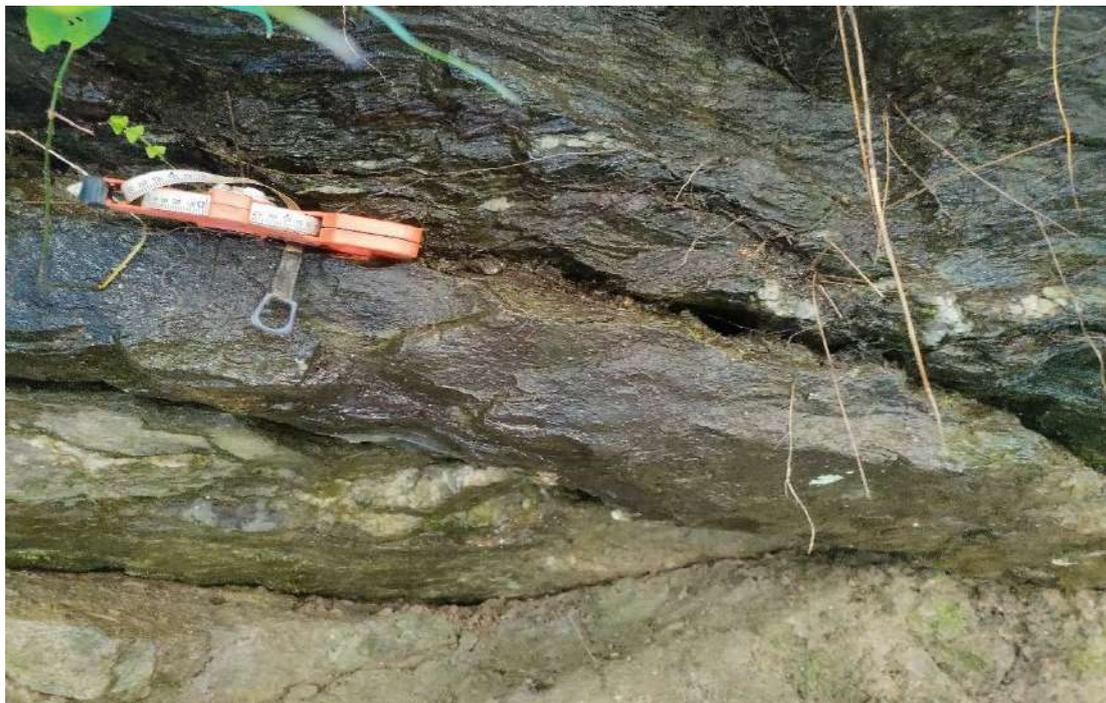
Photograph 5. Rock exposure observed near Kalshyong Khola.

Geologically, rock exposure of slightly to moderately weathered greenish grey phyllite interbedded with metasandstone was observed near spring (Photograph 5). Quartz vein of thickness 3 cm to 8 cm was also present in the phyllite which is almost parallel to its foliation. The thickness of the phyllite bed is up to 3 cm whereas the metasandstone has the thickness up to 15 cm. The groundwater condition of the rock exposure is drippy. The orientation of the bed including two joint sets were noted. The aperture of joint set 1 was about 2 cm to 4 cm.

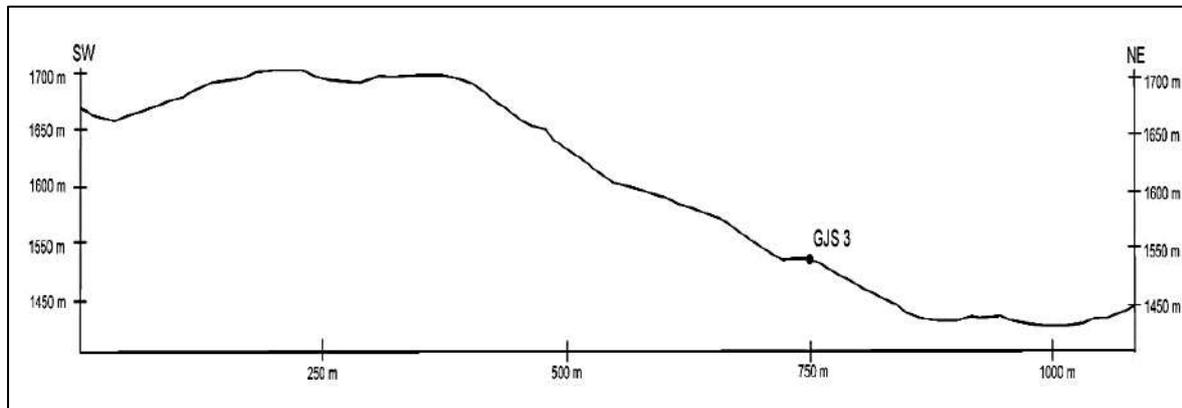
Figure 6. Elevation profile of Tawal Khola (Tawal).

The observation site lies close to Tawal village (Photograph 6). The origin of the source is a stream where the cliff is observed at both sides of the stream, covered with vegetation (Figure 6). The estimated discharge of GJS3 was 16 lps.

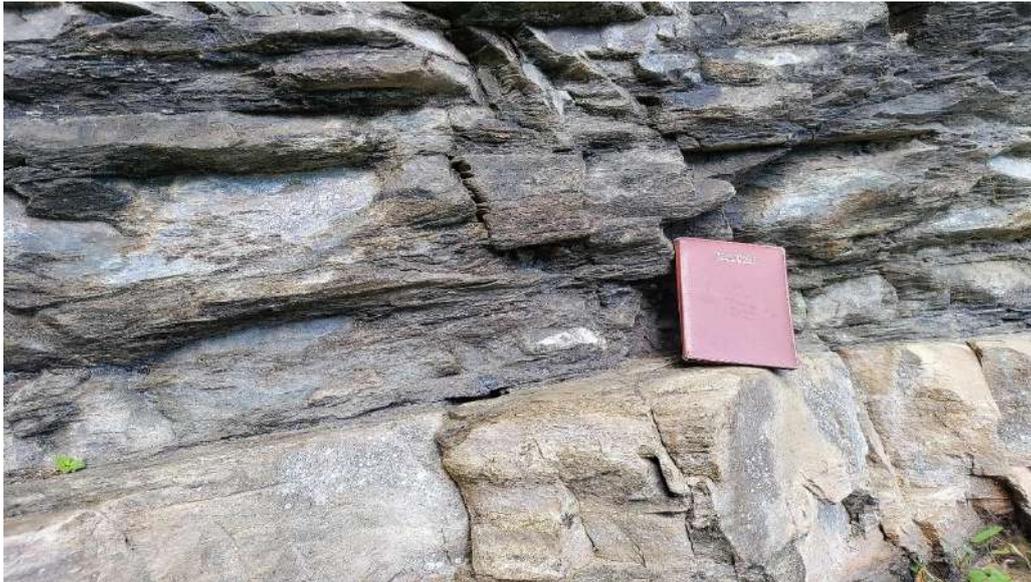
Photograph 7. Metasandstone interbedded with phyllite near Tawal Khola.

The rock exposure was observed near the observation sites at about 10 m away from the left bank of the Tawal Khola (Photograph 7). It consists of slightly to moderately weathered phyllite interbedded with slightly weathered fine grained metasandstone with the presence of the quartz vein in phyllite. Metasandstone was about 2 cm to 15 cm thick. The condition of ground of the rock exposure was wet. The orientation of three discontinuities including bedding (foliation) seen in rock exposure was also taken.

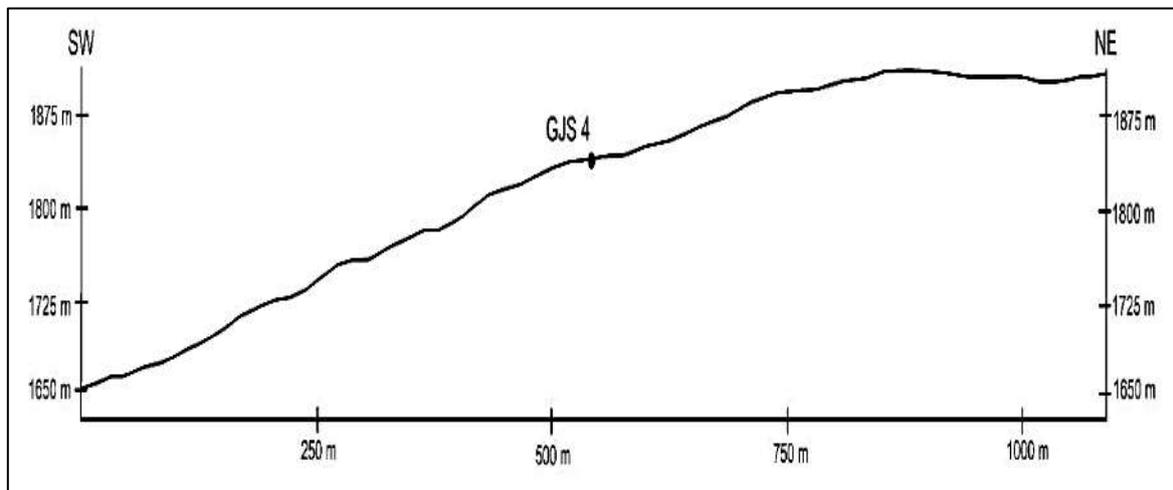
Figure 7. Elevation profile of Kimru Spring and surrounding.

Gravel and boulders of phyllite, metasandstone, quartz, etc. can be seen around the spring. Vegetation covers around the spring and terrace of cultivation land about 10-13 ropani at about 10 m uphill from the slope can be observed. This spring seems to emerge at the ground surface along the contact between a thin, permeable colluvial cover and an underlying low permeability phyllite and metasandstone bedrock.

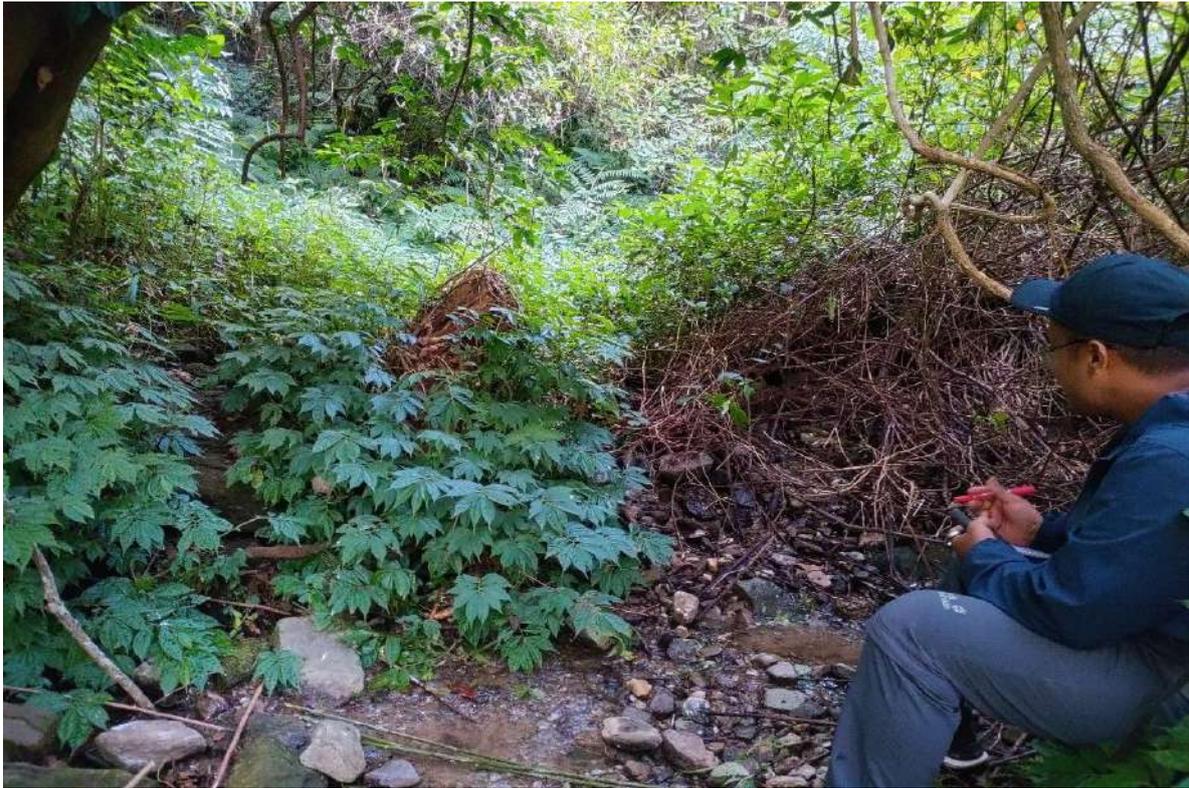
Photograph 8. Krimu Mul, a colluvium spring near the farmland at Reegaun.

Kimru spring is situated near Reegaun (Photograph 8). A study of the Kimru spring identified it as a colluvial spring, providing fresh water year-round, though its discharge markedly decreases during the dry season. The estimated discharge of GJS4 was 3.5 lps.

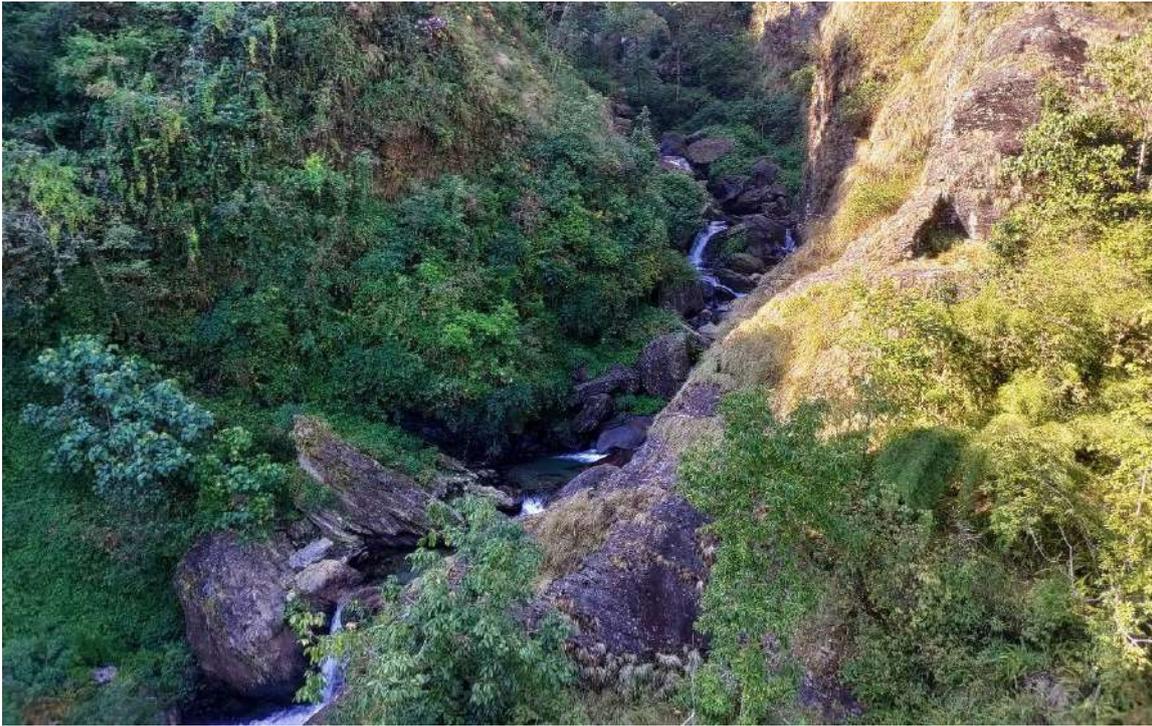
Photograph 9. Gortha Khola near Richet Village.

The observation site is situated in the vicinity of Richet Village (Photograph 9). It is a stream that converges with the Aakhu Khola. The estimated discharge of GJS5 was ~100 lps. It is a perennial stream whose discharge decreases during the dry season (Figure 8). The exposed rock formation near the Gortha Khola consists of slightly to moderately weathered greenish grey phyllite with an undulating surface. Quartz veins can be observed in phyllite.

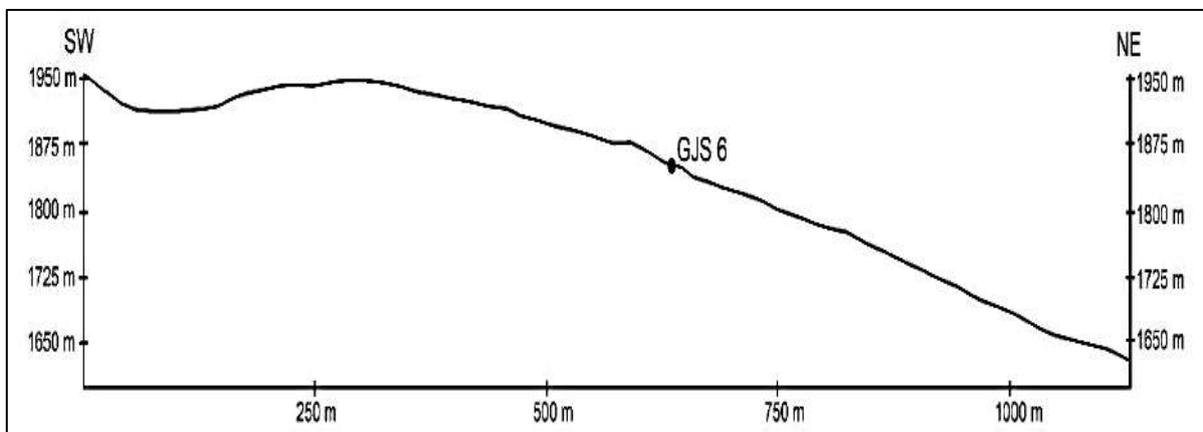
Figure 9. Elevation profile of Lakuridada Spring (Reegaun).

The source is located near Reegaun. The investigation reveals that the spring is colluvial (Figure 9). The estimated discharge of GJS6 was 7 lps. The area is covered with the loose sediments of gravel to boulder sized phyllite, metasandstone and the vegetation, making it difficult to locate the rock exposure during the visit (Photograph 10). The spring originates from these loose sediments. However, analyzing water flow data suggests that the perennial springs throughout the region are fed by deep fractures of underlying phyllite and metasandstone rock.
